## **REDUCING MOTOR SHAFT VOLTAGES**

A Report by Environmental Potentials'  
Research & Development Department

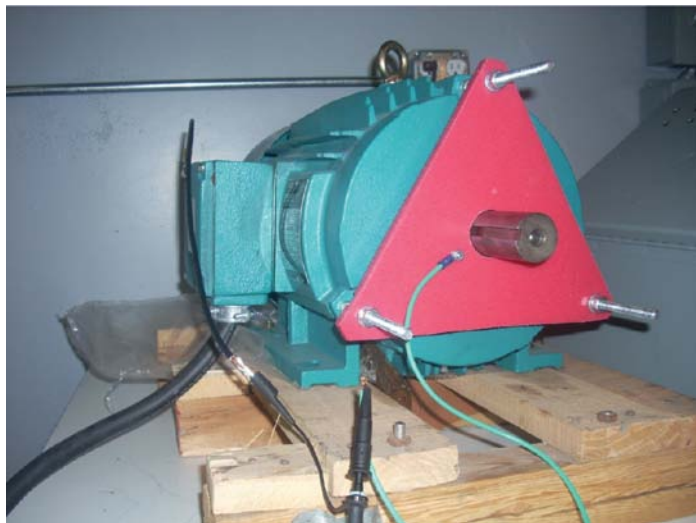
Figure 1 shows the test setup for measuring bearing currents. The motor is 3ph 480V delta motor with no load connected. A brush is installed at one end of the shaft and wires are connected to this brush. A separate wire is connected to motor casing. An oscilloscope is connected between these two wires (brush wire and ground wire) to measure the shaft voltage.

←  
**Figure 1:** Test setup to measuring bearing currents. Brush connected at the shaft with green wire out, and black wire out from motor casing.
